# JAMAICA AVENUE

# JAMAICA AVENUE EXISTING CONDITIONS SUMMARY

# ARCHER AVENUE EXISTING CONDITIONS SUMMARY

# SUTPHIN BOULEVARD EXISTING CONDITIONS SUMMARY

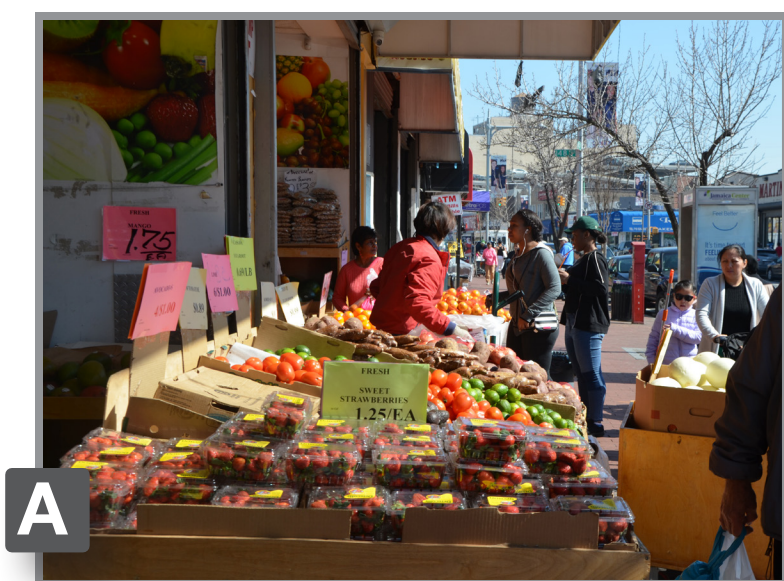
**A** Commercial land use is the prominent along the corridor. Local businesses such as grocery stores are concentrated near Sutphin Boulevard. Activity often spills onto the sidewalk.

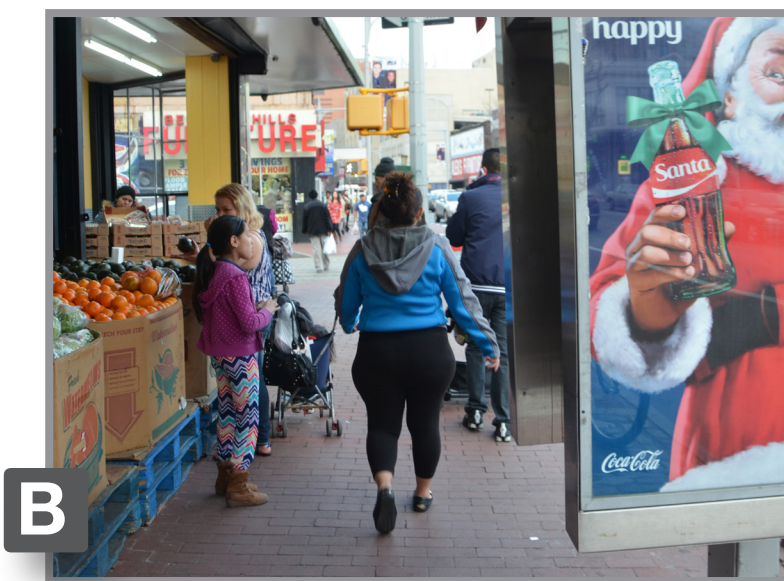
**B** Placement of amenities on sidewalk causes narrowing and pinch points along Jamaica Avenue.

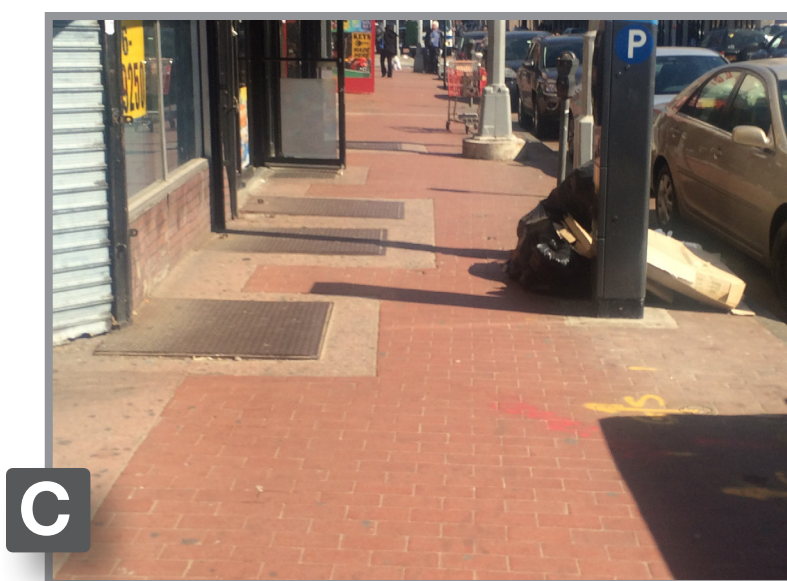
**C** Red brick pavers are the prominent sidewalk material. Retail basement access, vents, and vaults can be found between Sutphin Boulevard and 150th Street.

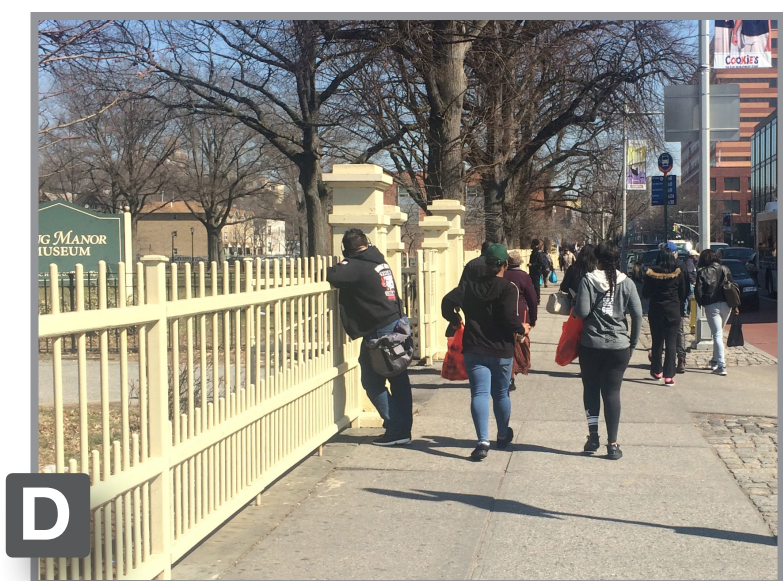
**D** Rufus King Park is a 12-acre regional recreational destination fronting Jamaica between 150th and 153rd Street. The King Manor Museum, an historic landmark, is located near this frontage. The current perimeter fence limits access to the park and is a visual barrier.

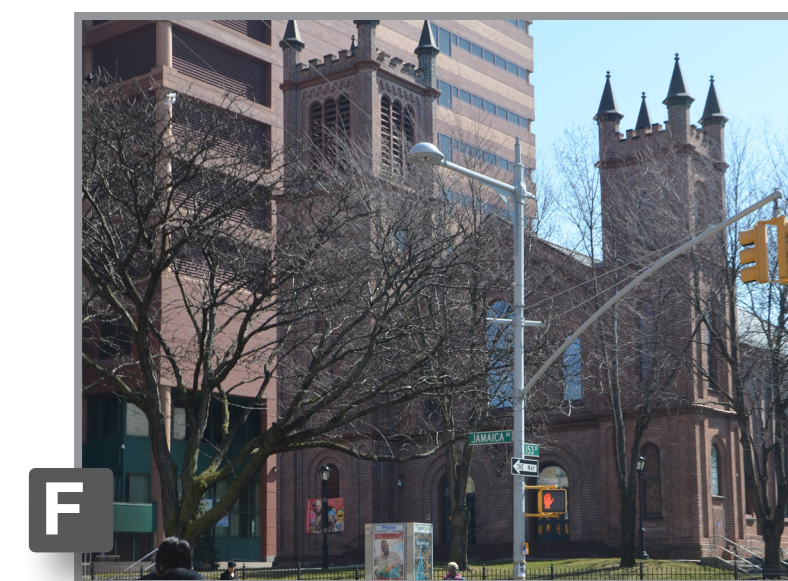
**F** Major cultural destinations are often located in historic buildings. For example the Jamaica Performing Arts Center occupies the former First Reformed Church surrounded by gated private open space, at the 153rd Street intersection.

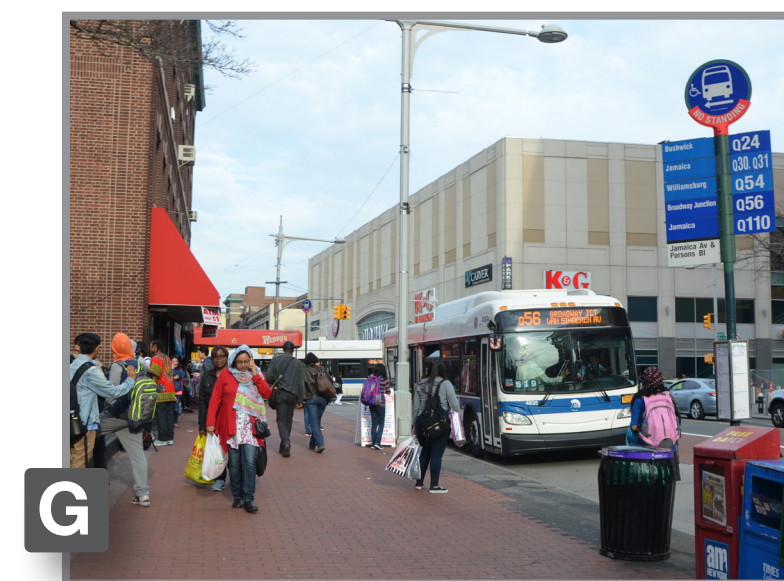
**G** Sidewalk congestion from waiting passengers were observed at transit facilities such as bus shelters and ticket kiosks along the corridor.

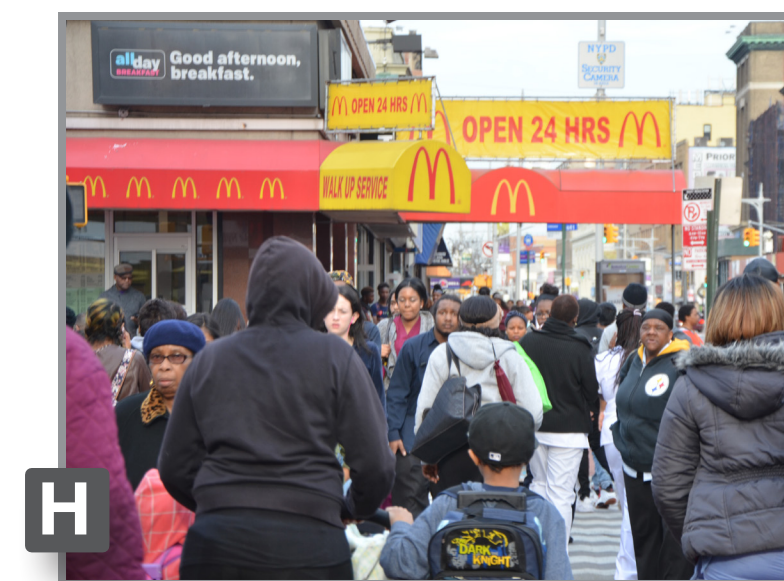
**H** Visual clutter from overhead shelter advertising dominate pedestrian view corridors. 'A' frame signs clutter sidewalk space.

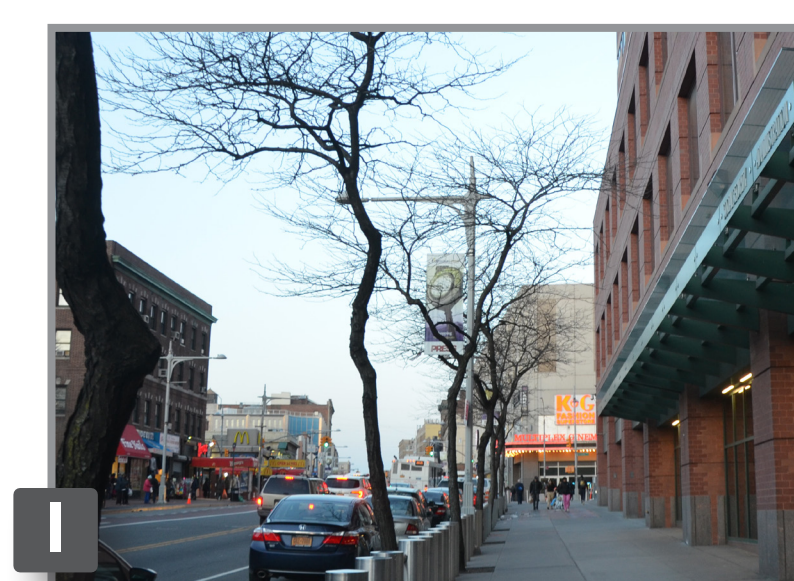
**I** Jamaica Avenue has sporadic tree coverage of varying health and maturity. Recently planted trees near the Social Security Building are spaced at 20-25ft intervals.

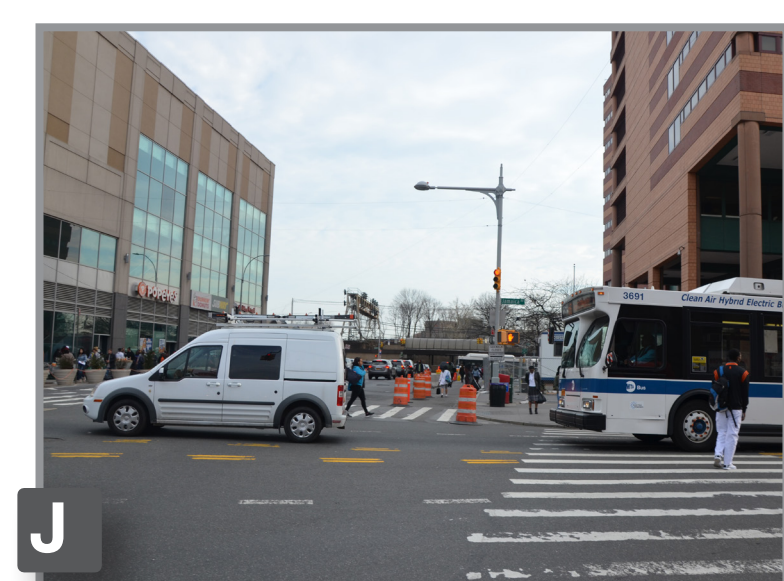
**J** Jamaica Avenue functions as a key transportation corridor. Dedicated bus lands operate in both directions. High bus volumes especially during peak times create a noisy streetscape environment.

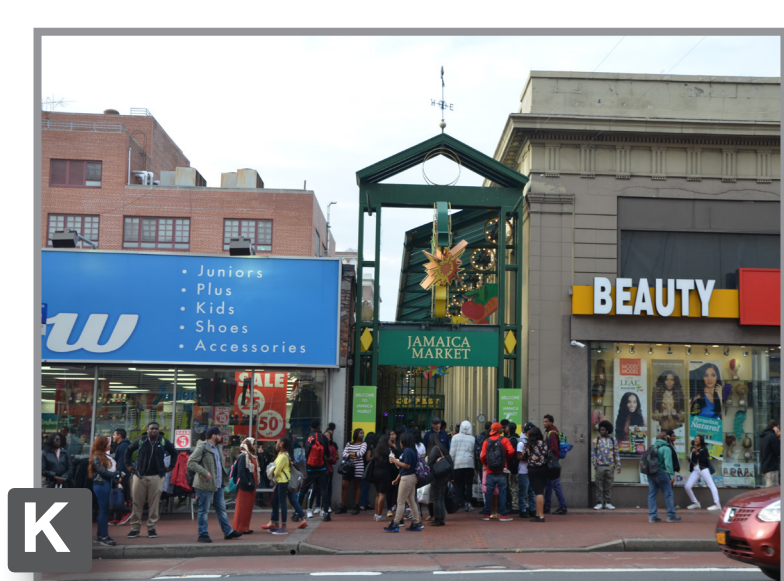
**K** Sidewalk congestion from dispersion at destination entrances such as Jamaica Market and Multiplex Cinemas disrupt travel patterns.

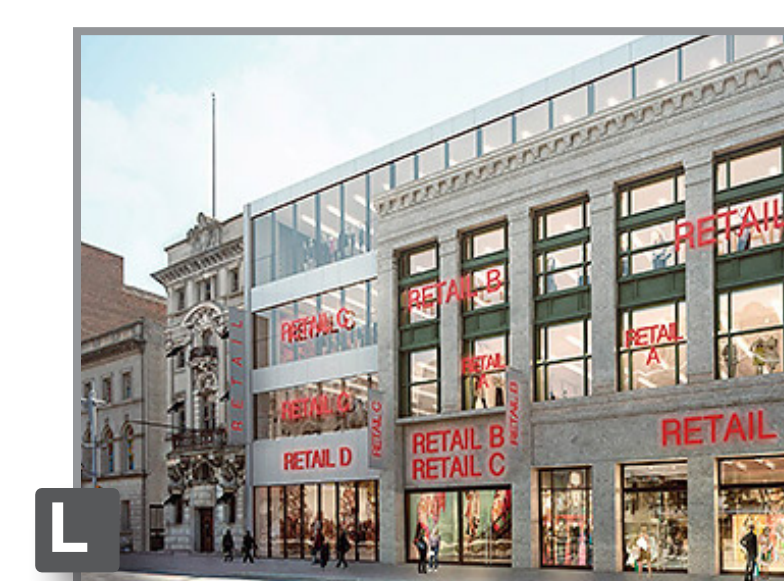
**L** Planned retail development between 160th and 161st Street, involves the amalgamation of three separate parcels into a large retail floor plate.

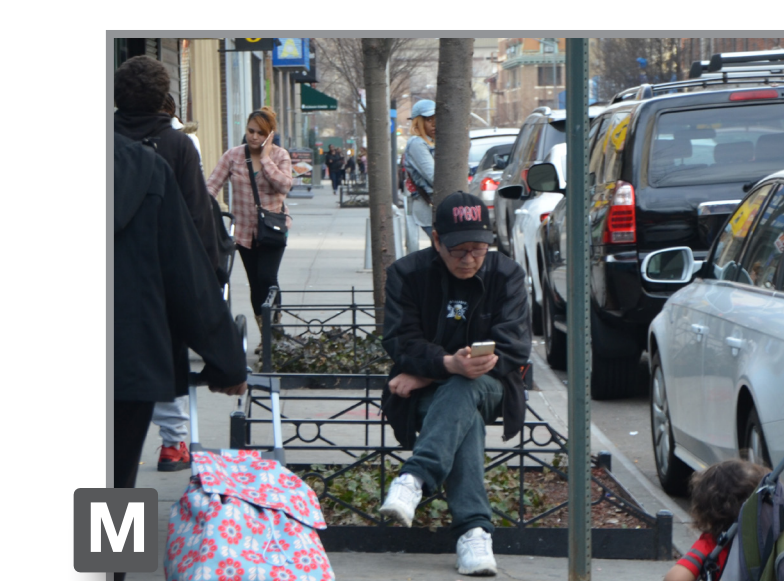
**M** There is a general lack of seating throughout corridor. Fire hydrants, tree pit shields, subway vents, and building elements have been observed as seating substitutes.

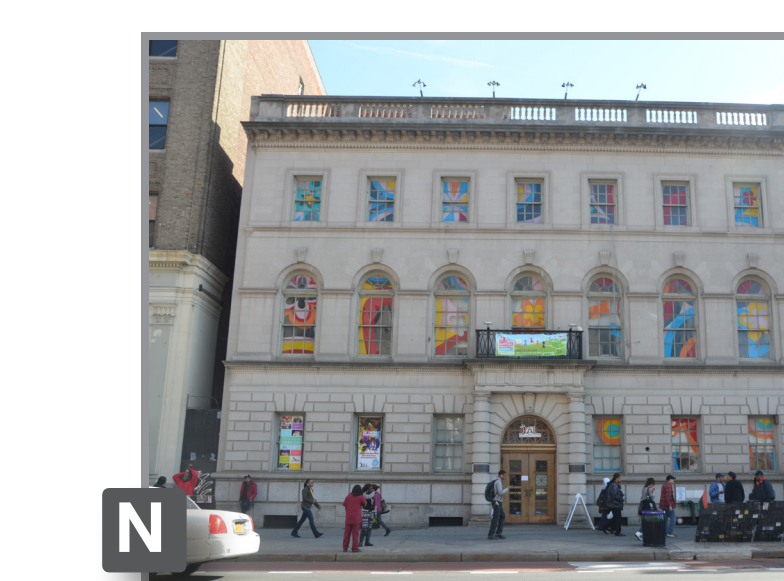
**N** Major regional cultural destinations such as JCAL, JPAC and King Manor Museum are located along the corridor.

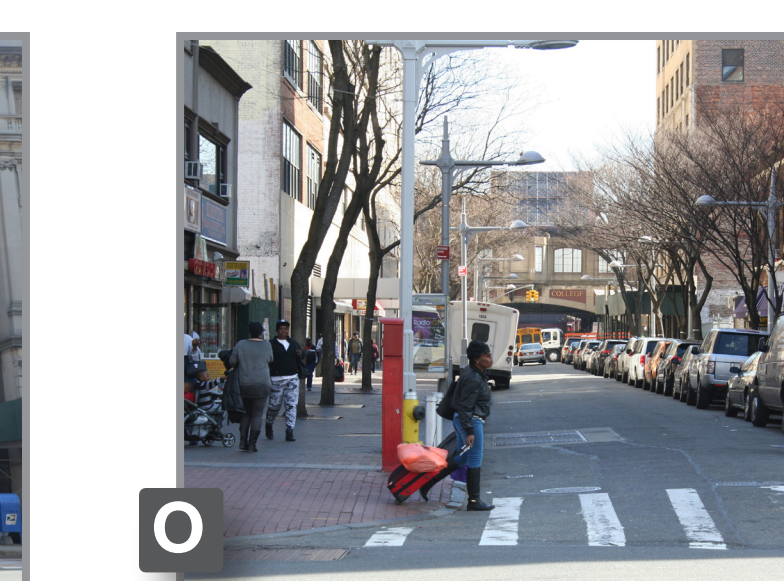
**O** Narrow streets in between Jamaica and Archer Avenue have the potential to provide refuge from the noise and bustle of Jamaica Avenue.

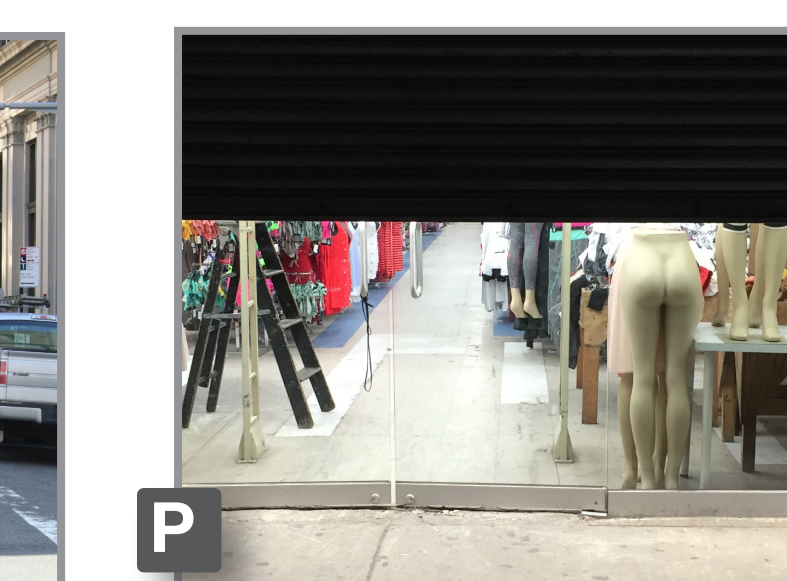
**P** Light from retail and local business facades contribute to a lit and inviting nighttime experience. Security gates on retail stores after closing hours detract from the nighttime environment.

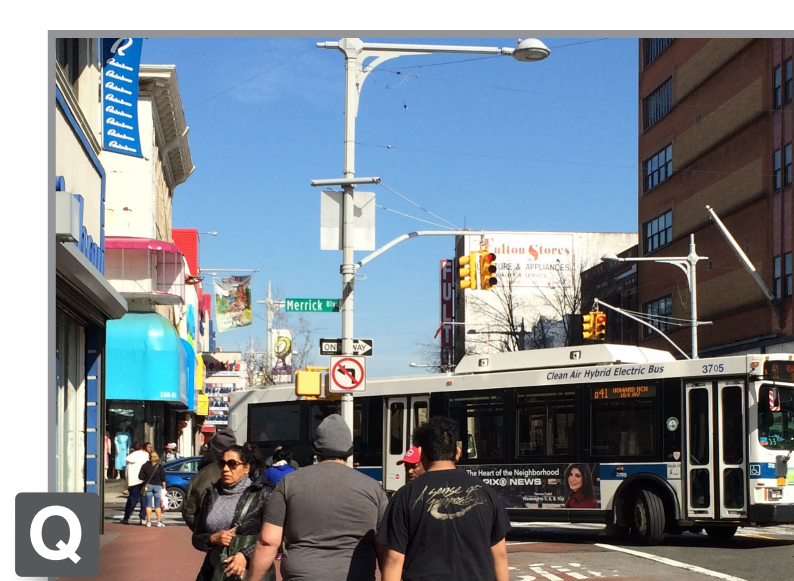
**Q** Overall lighting levels meet standards. Distinctive art deco style TBTA Poles used throughout corridor at approximately 75 foot spacing. No pedestrian scaled lighting.

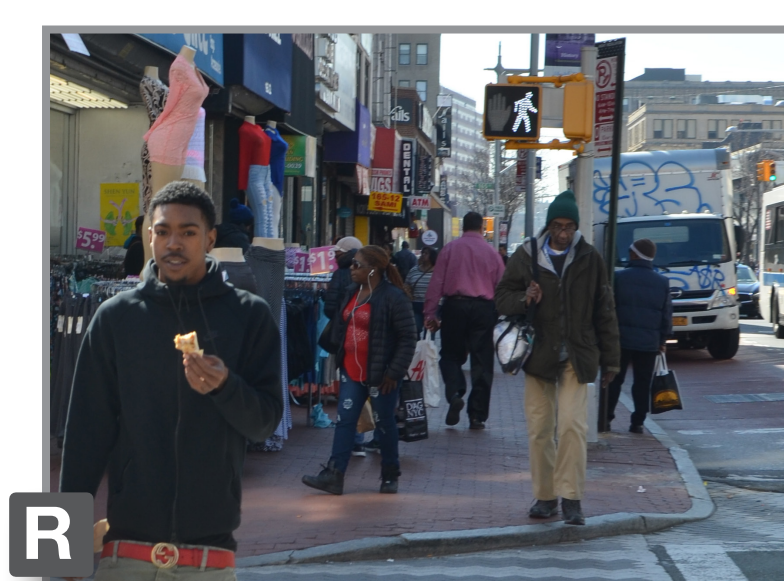
**R** Increased pedestrian activity east of Parsons Boulevard corresponding to its retail character and concentration of regional destinations. Reinforcing the need for materials to withstand high foot fall traffic.

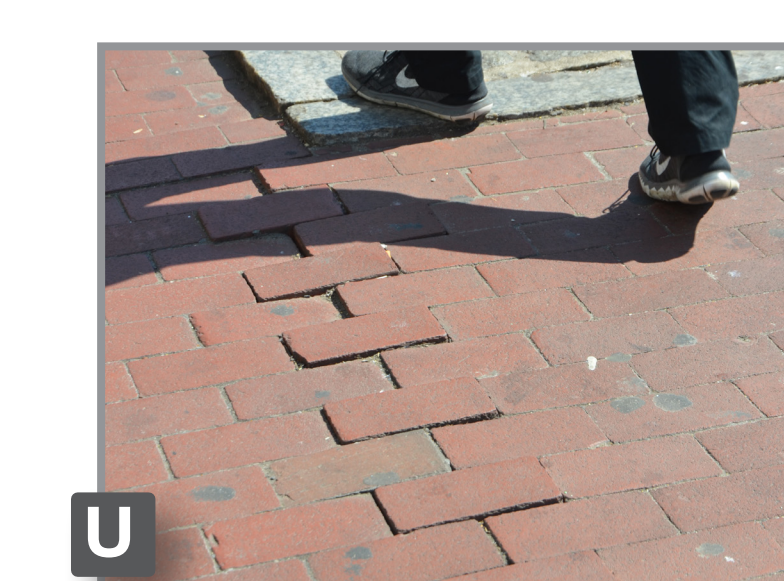
**U** Strong presence of red brick pavers from Sutphin Boulevard to 169th Street. Although a distinct feature, some bricks were observed to be dislodged.

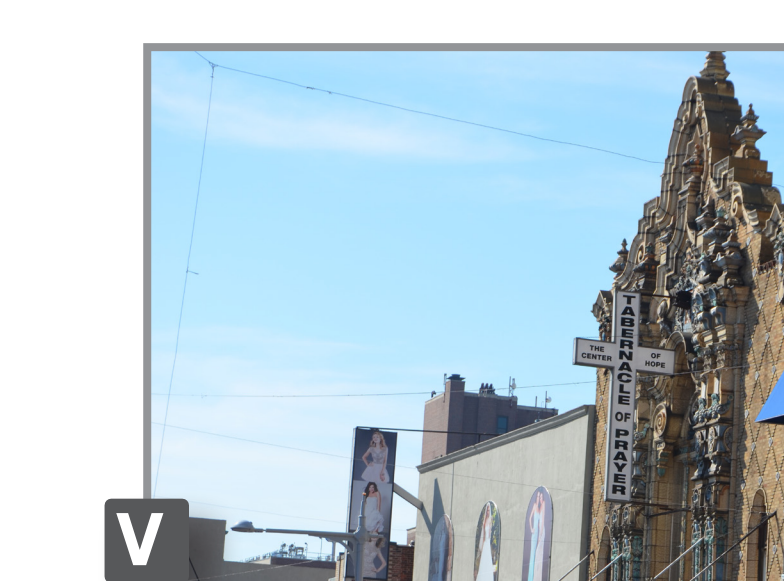
**V** Many historic listed facades of neoclassical and art deco styles add visual character and interest along the corridor. The Valencia Theater, Kurtz Building, and Title and Deeds Building are key examples.

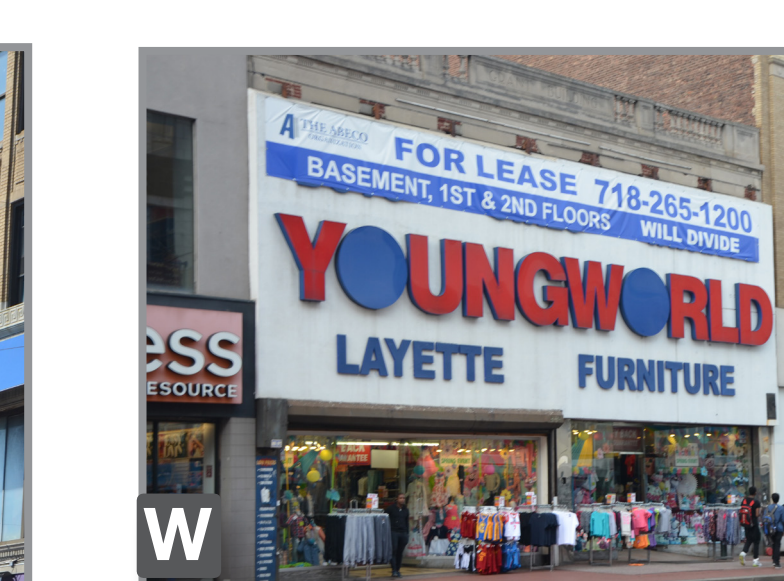
**W** Visual clutter from over-scaled commercial and retail signage is pervasive, and detracts from the streetscape environment.

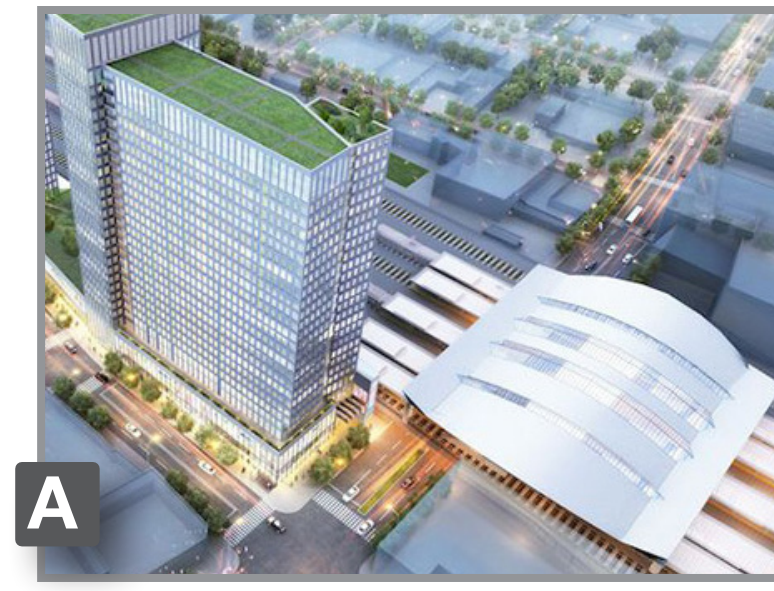
**A** Light industrial area in transition to new uses including mixed commercial, residential and hotel use.

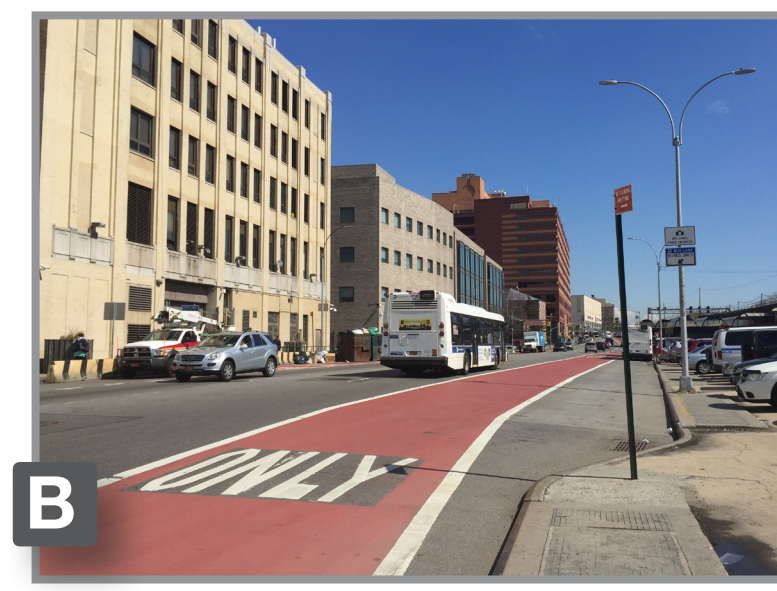
**B** Large commercial buildings (8-12 story) on the north side with good solar access.

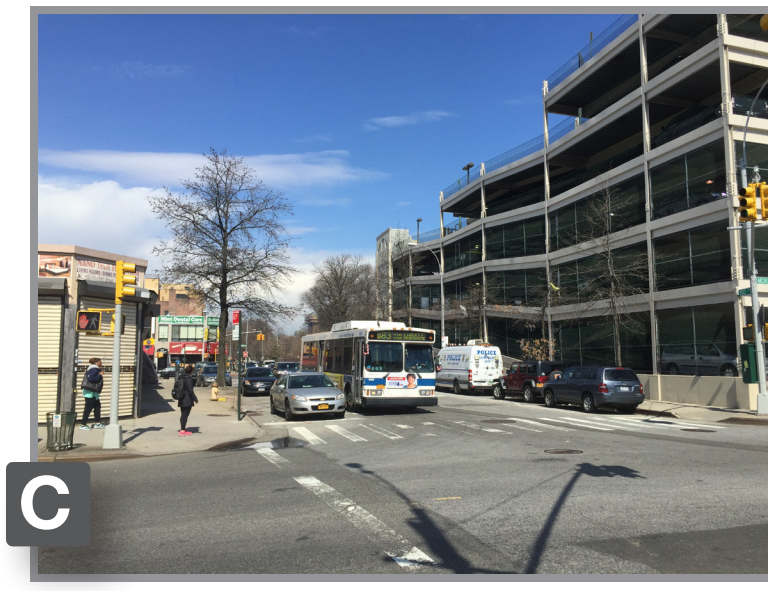
**C** Many parking garages along the corridor.

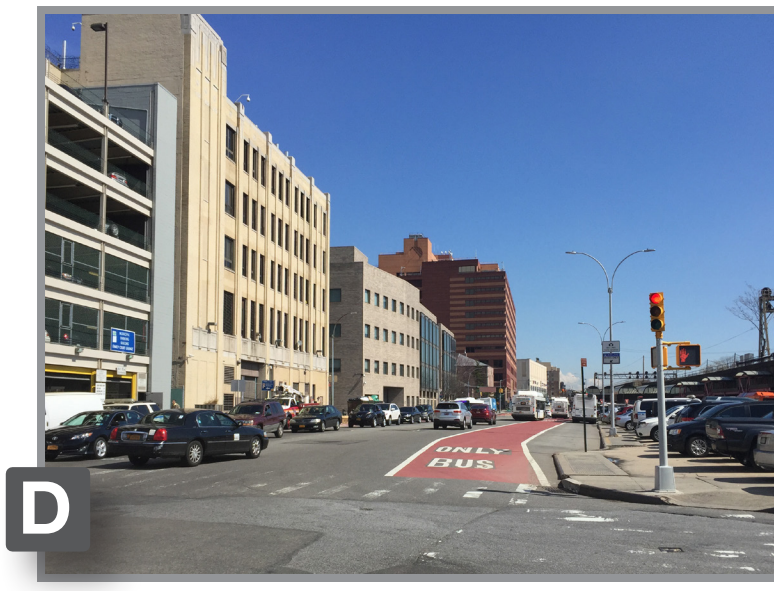
**D** View corridor is directed by continuous linear rail viaduct. Grade changes and curved road geometry interrupts direct views.

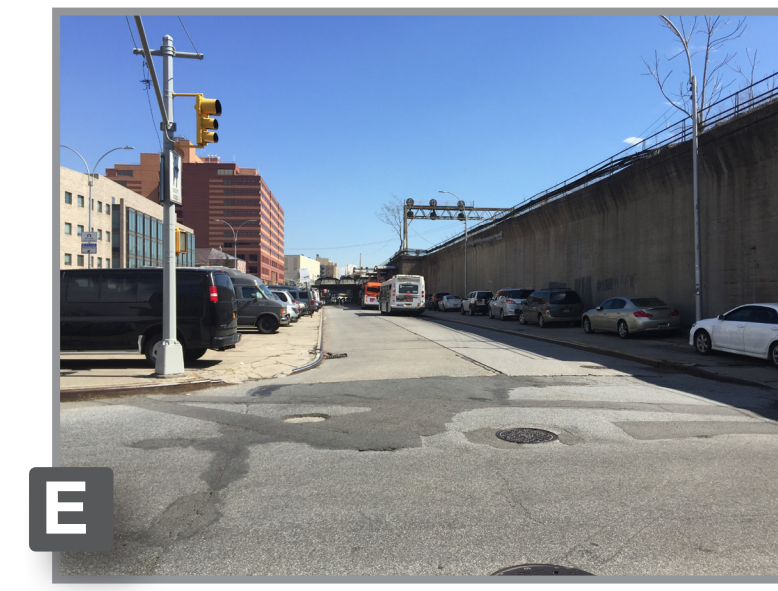
**E** Narrow parcels along rail viaduct used for linear transit shelters and parking.

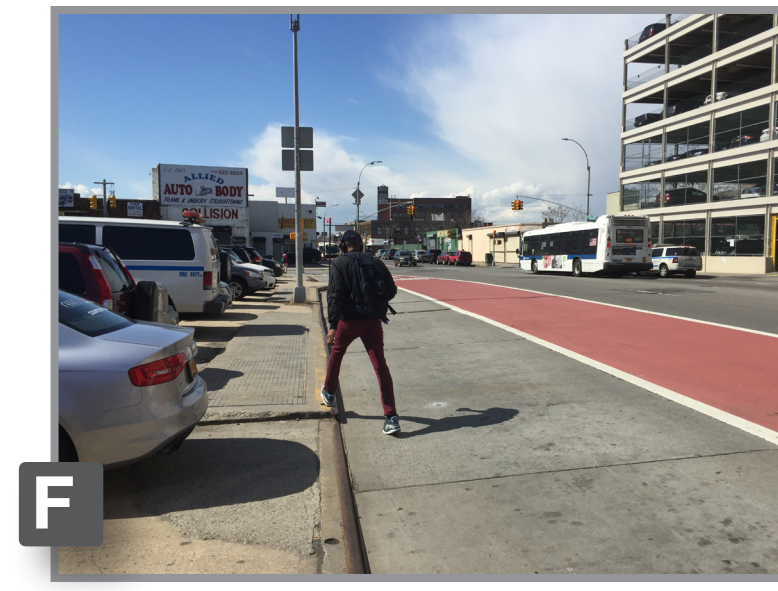
**F** Triangular site currently utilized for bus transfers with resulting awkward road operations and geometry. Unsafe for pedestrians.

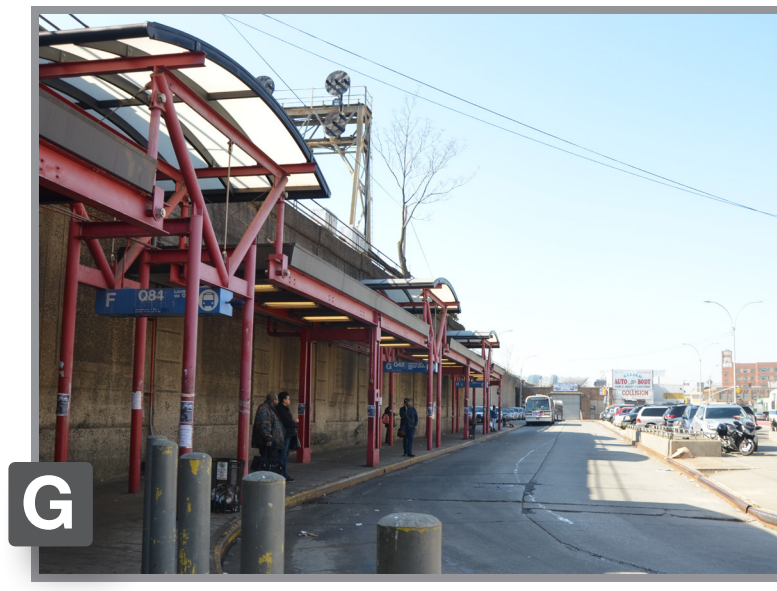
**G** Unpleasant pedestrian environment: noisy amid high traffic volumes, minimal pedestrian amenity, and no solar access.

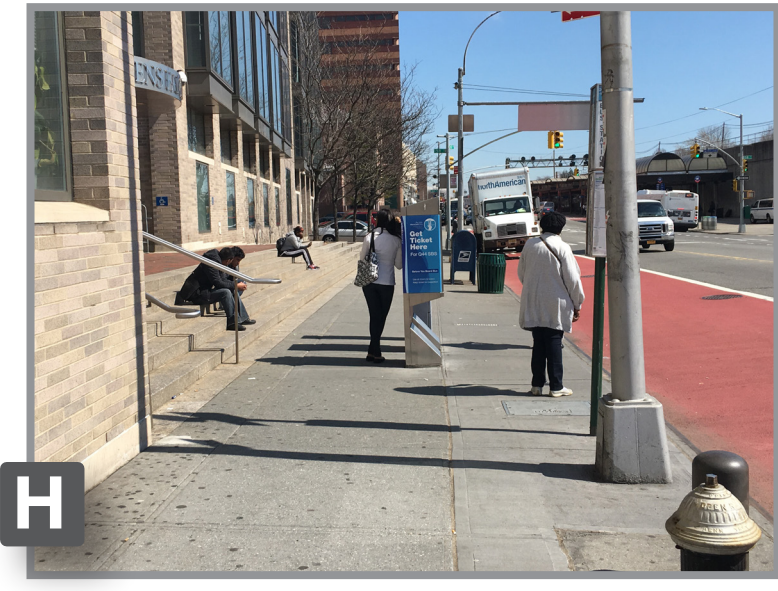
**H** Few public spaces with seating along corridor. Queens Family Courthouse steps are used for seating and have good solar access.

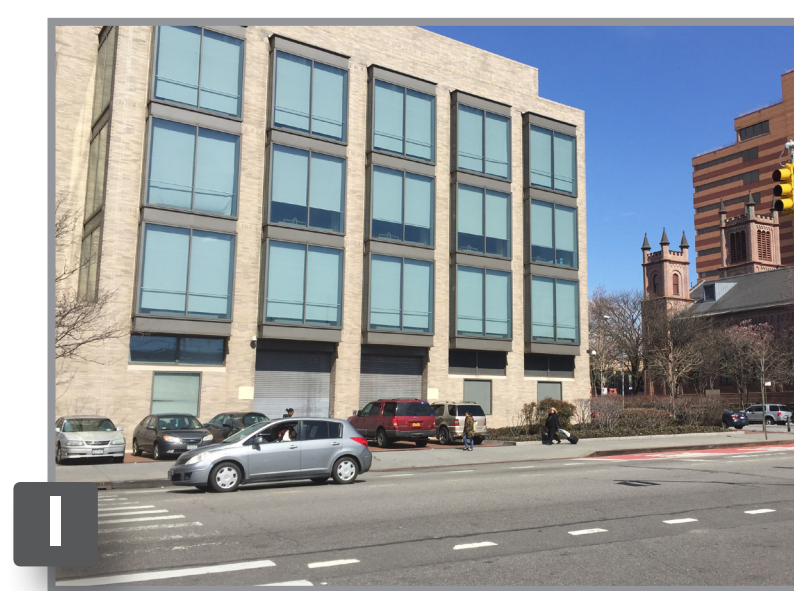
**I** Many ground floors are comprised of "back of house" elements such as driveways, service entrances, blank walls, mechanical uses, and vents.

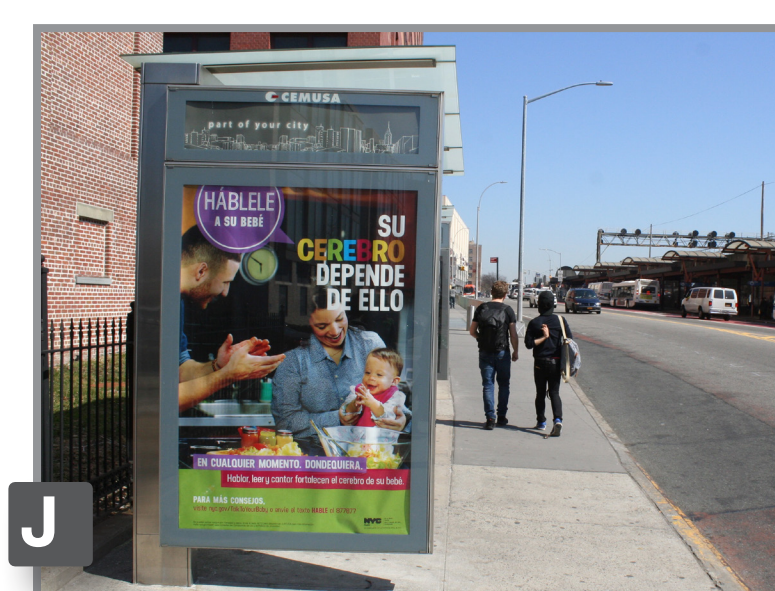
**J** Large, standardized bus shelters and newsstands dominate narrow sidewalk.

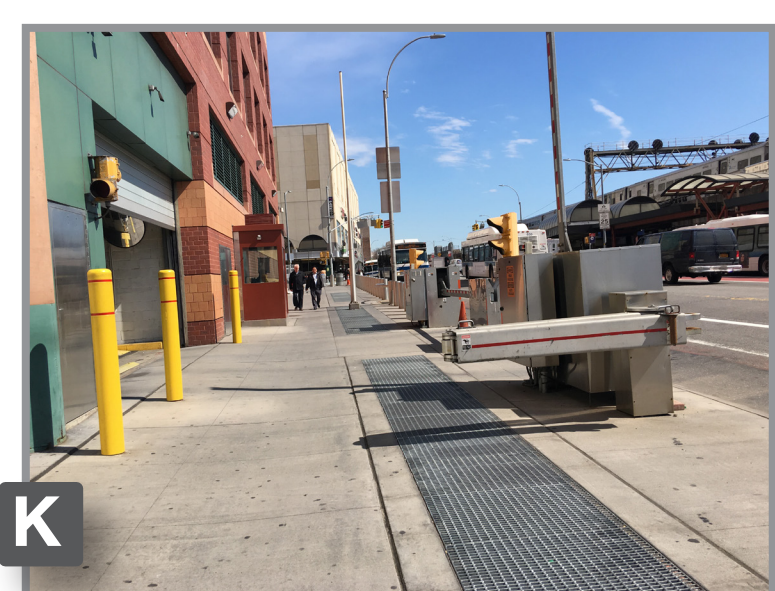
**K** Subway Vents along Archer Ave (from Sutphin Boulevard to Parsons Boulevard).

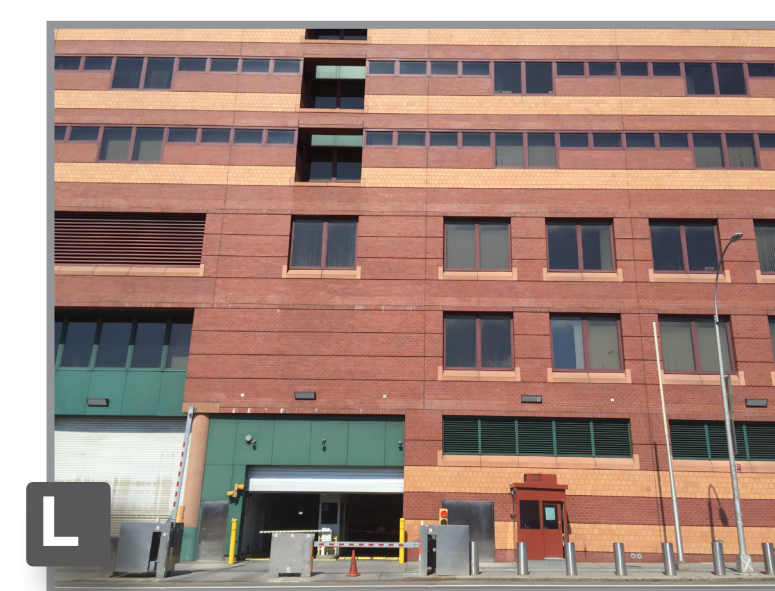
**L** Sidewalk at the Social Security Building interrupted with bollards, giant planters, blank facades, and driveways.

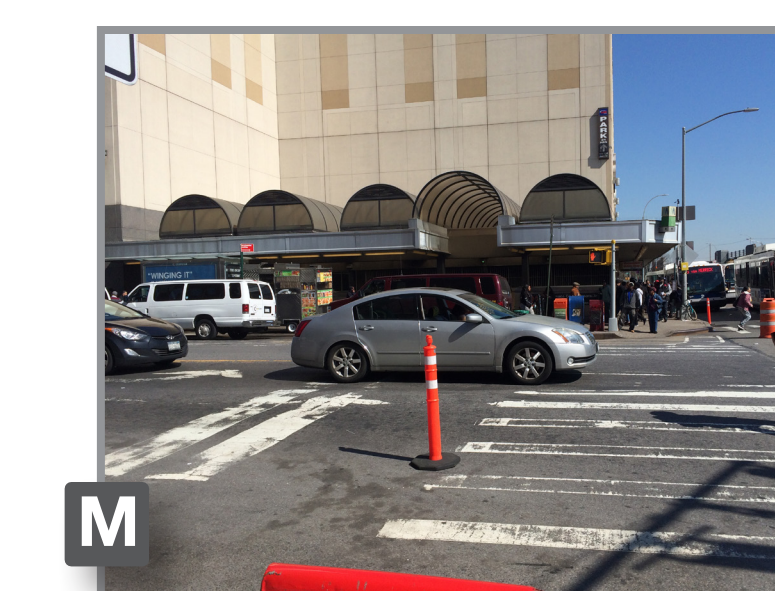
**M** Very active public transportation corridor that includes: LIRR Station, AirTrain, 2 Subway stations and over 50 bus routes.

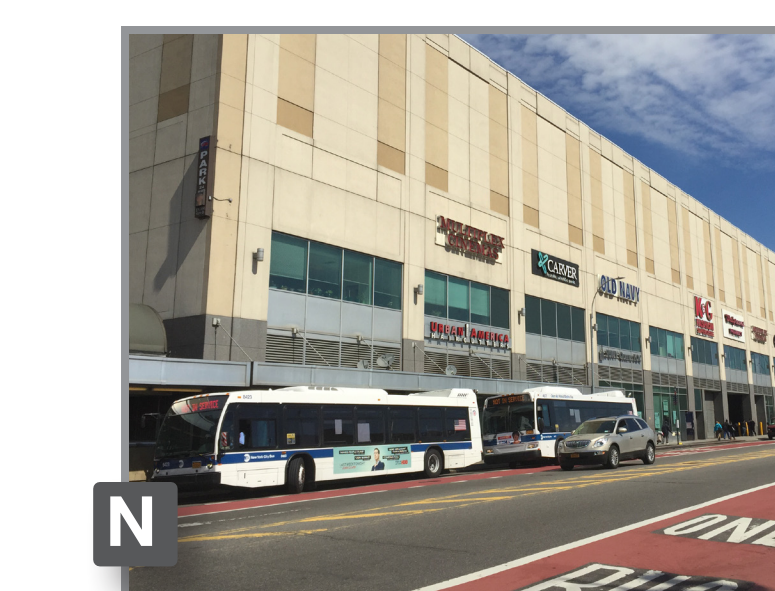
**N** ROW varies from 40 feet (at Sutphin Boulevard), to 72 feet (east of Parsons Boulevard). Bus lanes operate in both directions.

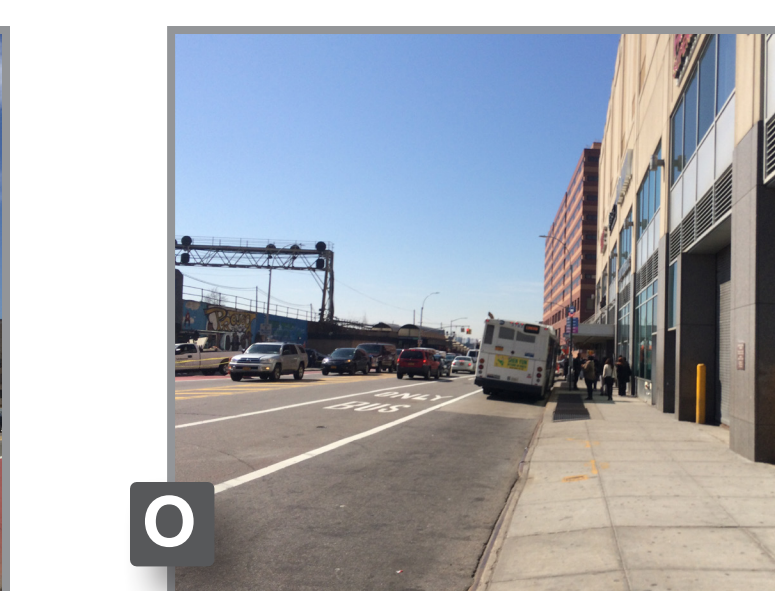
**O** Areas of intermodal conflict:

- Frequent curb cuts
- Surface parking lots
- Service entries

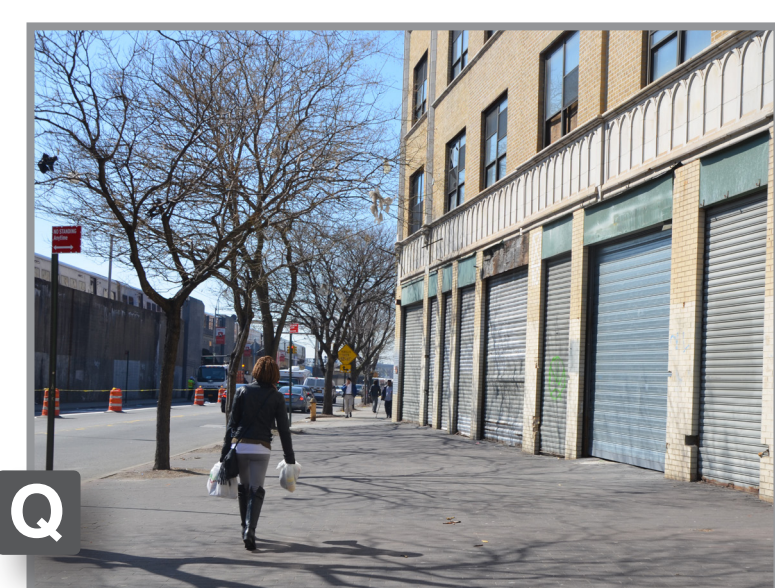
**Q** Dispersed tree coverage on northern side, no landscaping on southern side. Larger Plane Tree species toward the east with standard tree beds.

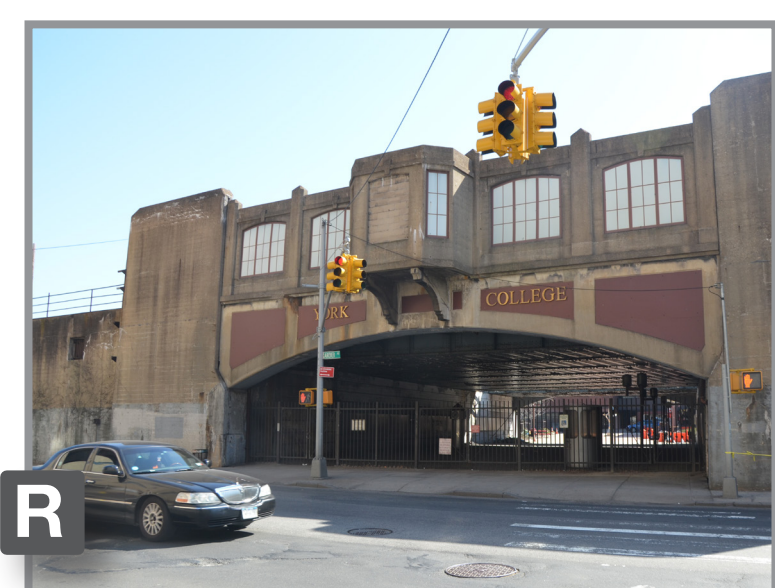
**R** Strong desire lines to York College. Viaduct is a barrier for pedestrian movement and tunnel conditions are poor.

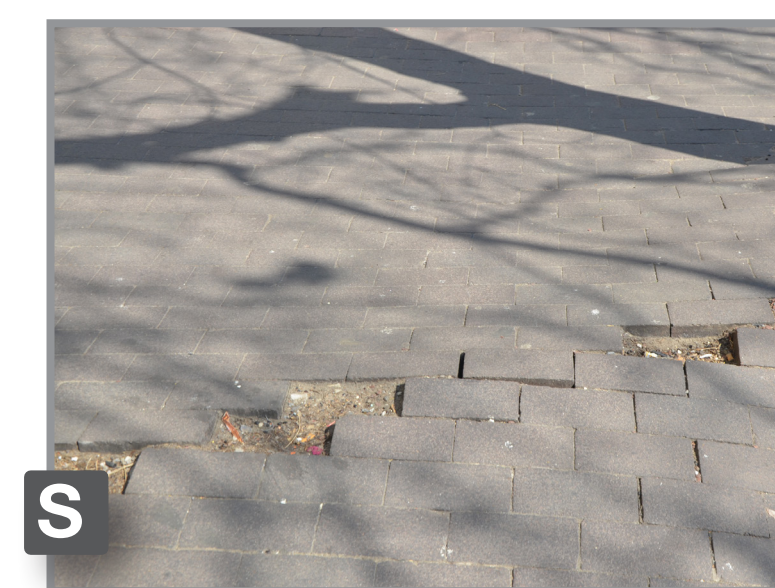
**S** Good to poor sidewalk conditions, with varying materials of concrete and brick pavers.

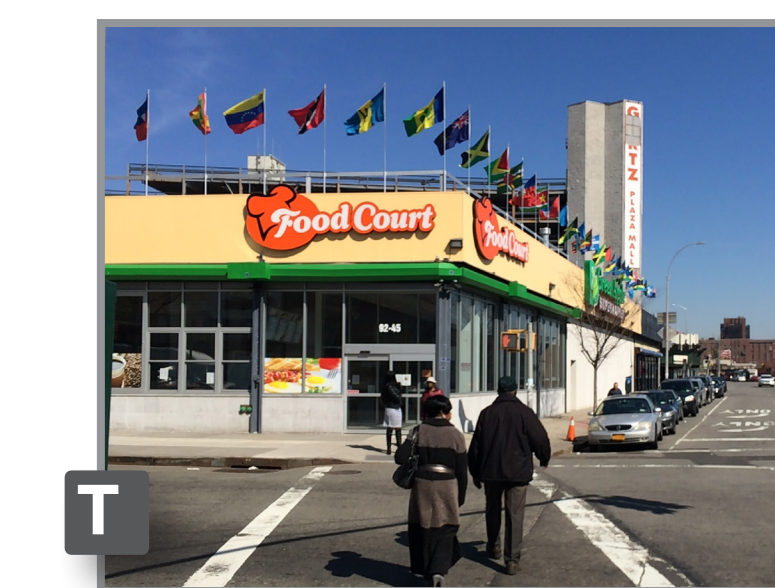
**T** Long pedestrian crossings at intersections with faded markings. Some T-intersections without pedestrian crossings.

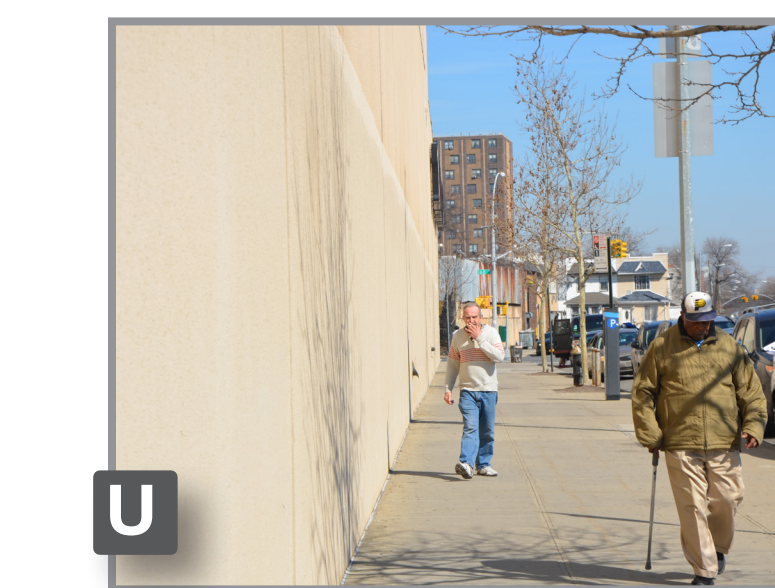
**U** Big box retail developments towards the east of corridor, result in blank facades and surface parking environments.

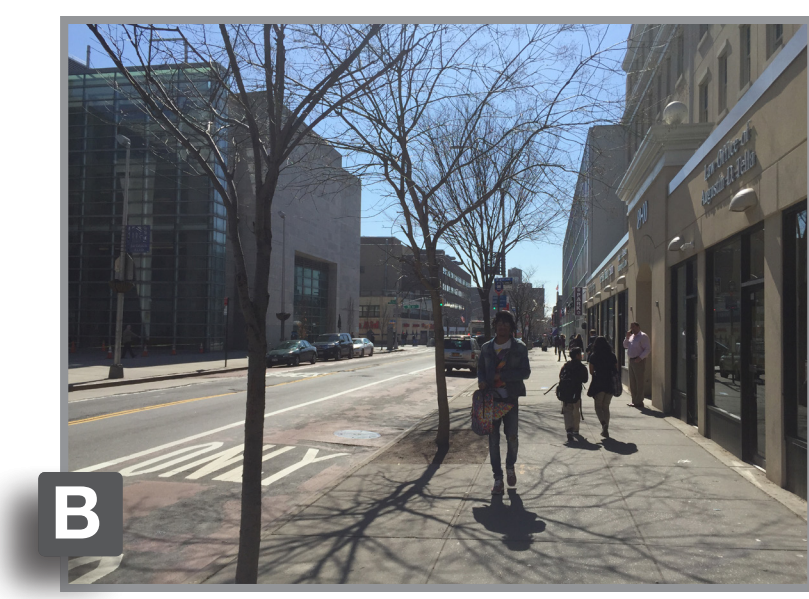
Street trees are planted at regular intervals along Sutphin Blvd. Trees vary in health and maturity.

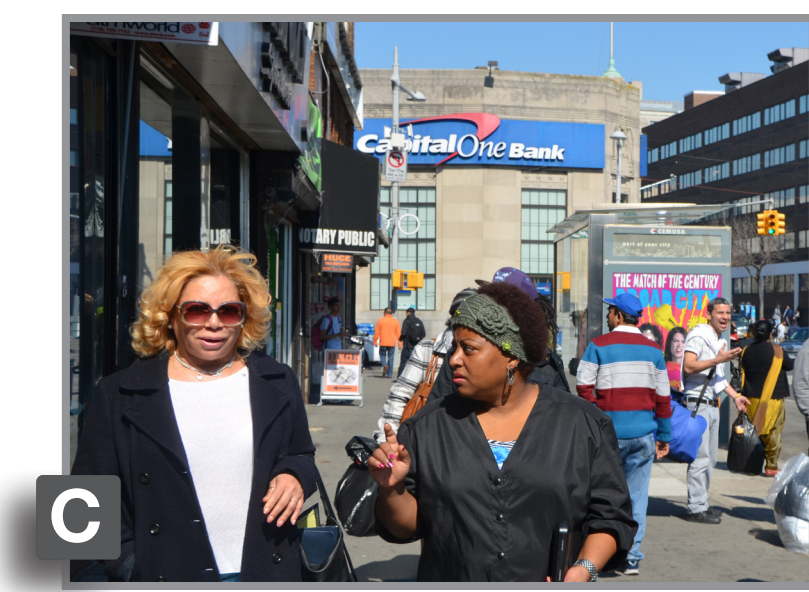
Sutphin Boulevard gently curves at Jamaica Avenue, creating changing view corridors. The northern view corridor directs to the Capital One Bank building.

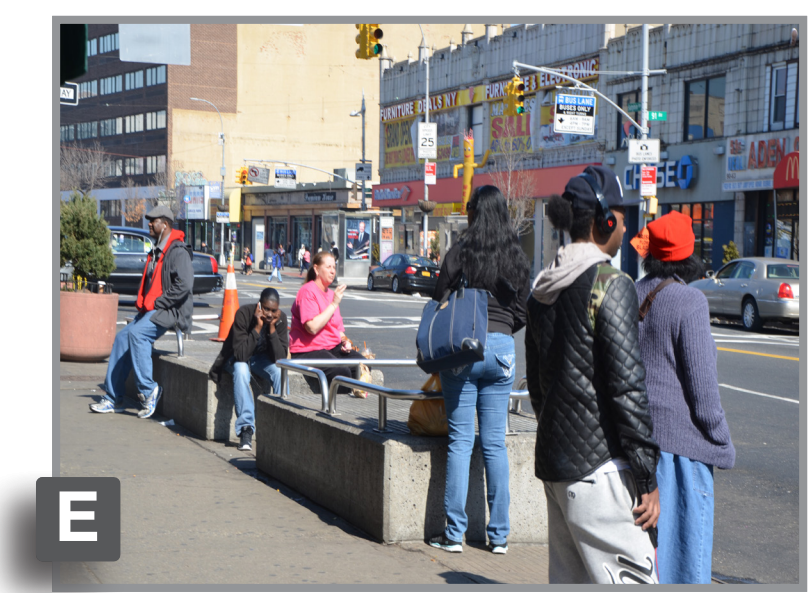
Subway vents near bus stops used as seating by waiting passengers. Waiting passengers and pedestrians create pedestrian congestion at this very active corner.

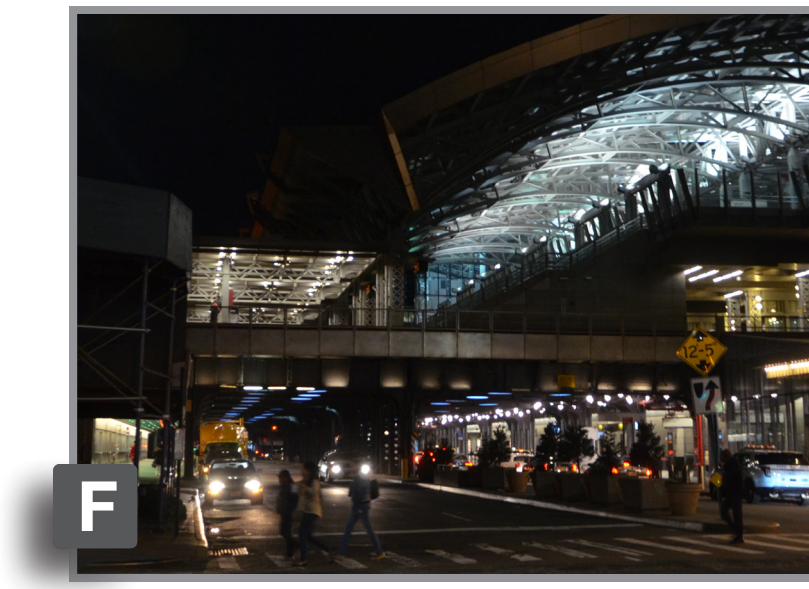
The iconic LIRR Station and underpass are illuminated landmarks in the nighttime. A combination of public street lighting and private commercial lighting illuminates the corridor.

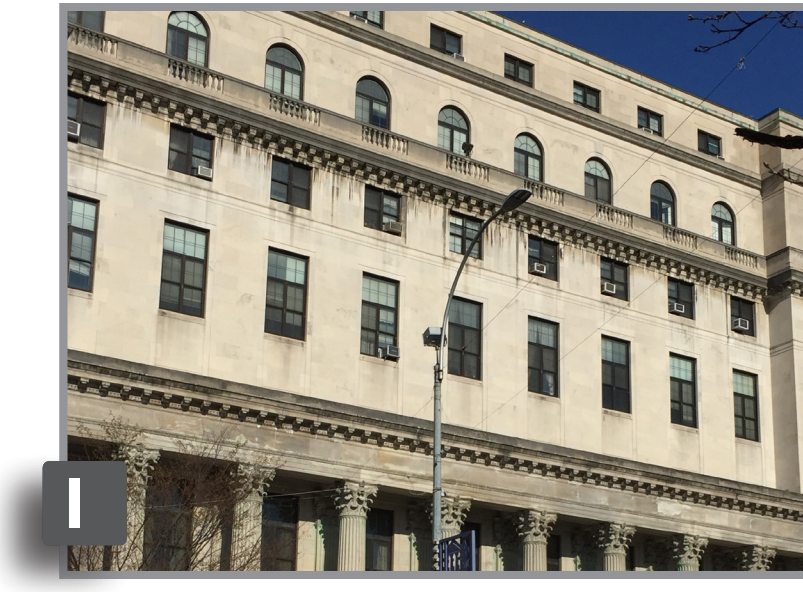
Standard street light fixtures can be found throughout the corridor. Flood lights accent features of the Queens Supreme Court building.

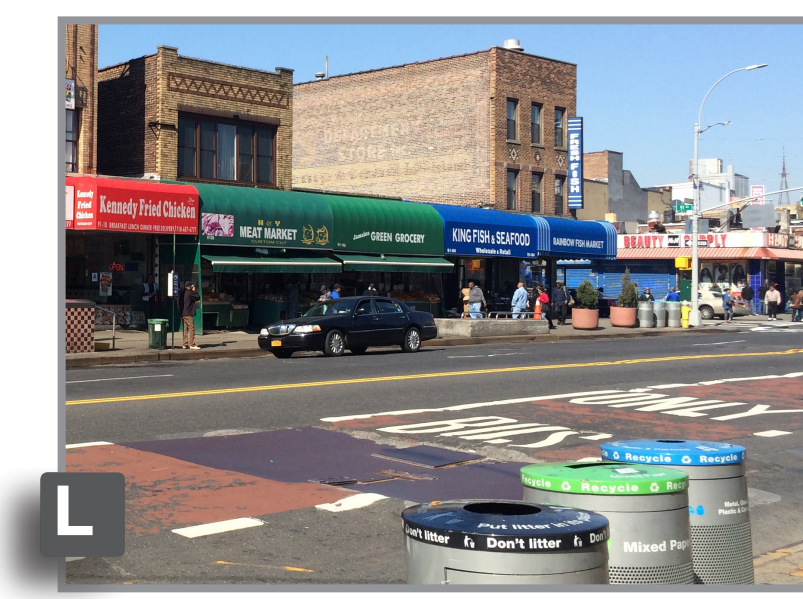
Bus-only lanes operate in both directions along Sutphin Boulevard. Parking is permitted in bus lanes outside of rush hours, typically 9am to 4pm.
