# JAMAICA AVENUE

# JAMAICA AVENUE EXISTING CONDITIONS SUMMARY

# ARCHER AVENUE EXISTING CONDITIONS SUMMARY

# SUTPHIN BOULEVARD EXISTING CONDITIONS SUMMARY

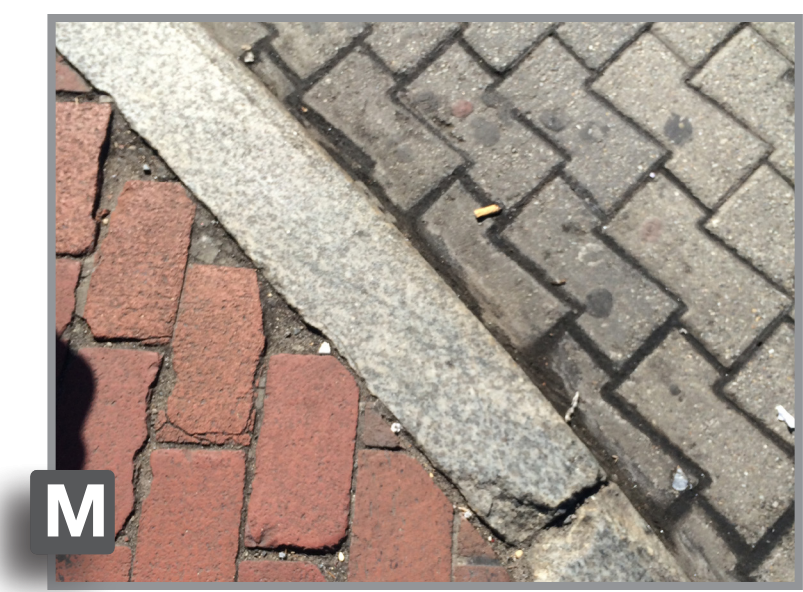
Sidewalks from Archer Avenue to Hillside Avenue are in generally good condition. A wide range of materials is used including brick pavers, poured concrete, and granite curbs.

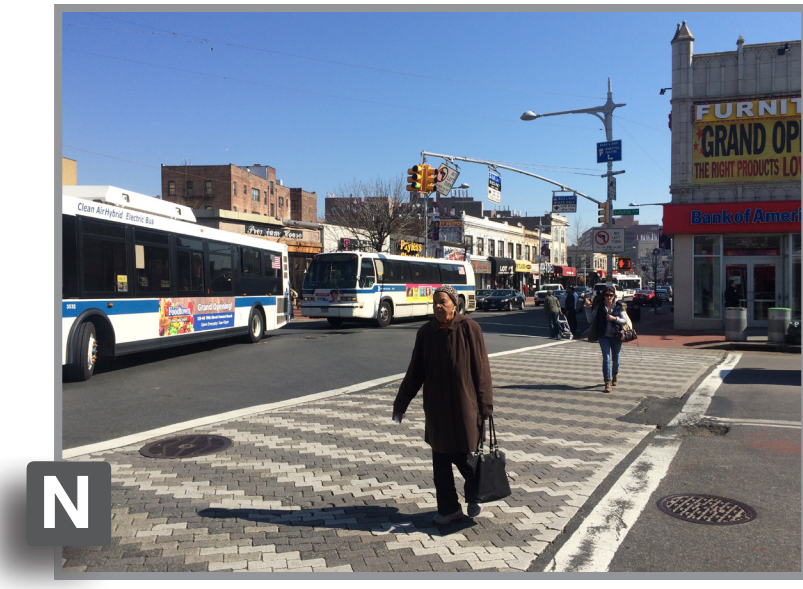
Intersections throughout Sutphin Boulevard provide adequate crossings. Crossing markings near Hillside Avenue are outdated and faded, and distinct zig-zag pavers are used at Jamaica Avenue intersection.

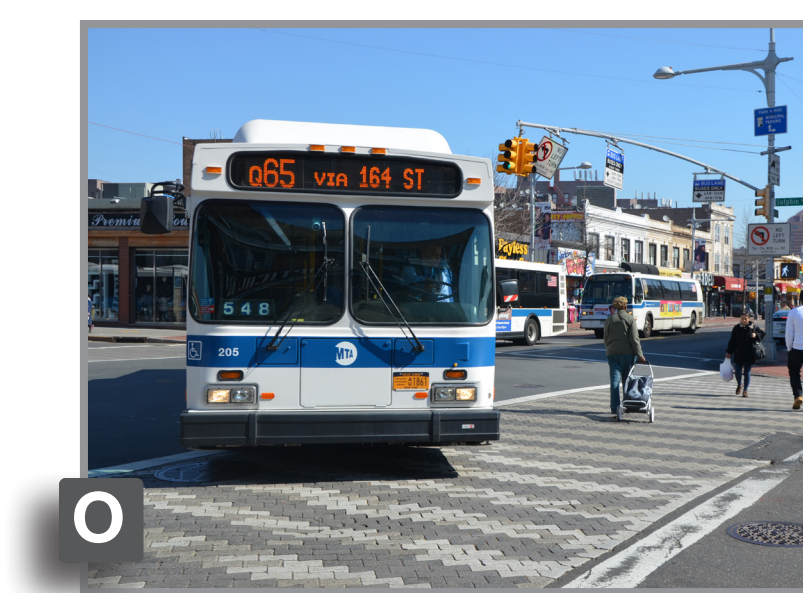
Sutphin Boulevard is a high volume transit corridor. Particular in rush hours, high bus volumes contribute to a noisy streetscape environment.

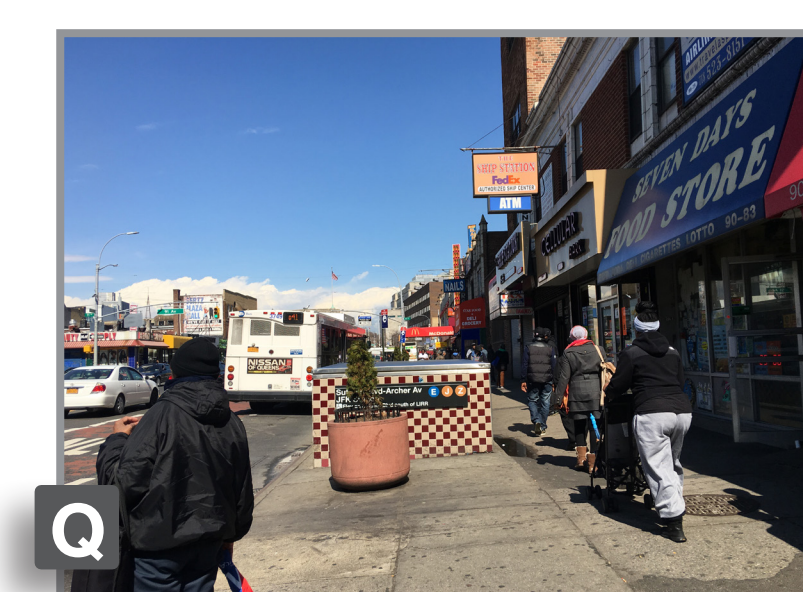
Sidewalk ranges from 12-20 feet along the corridor, with various pinch points near bus stops in particular between Jamaica and Archer Avenue.

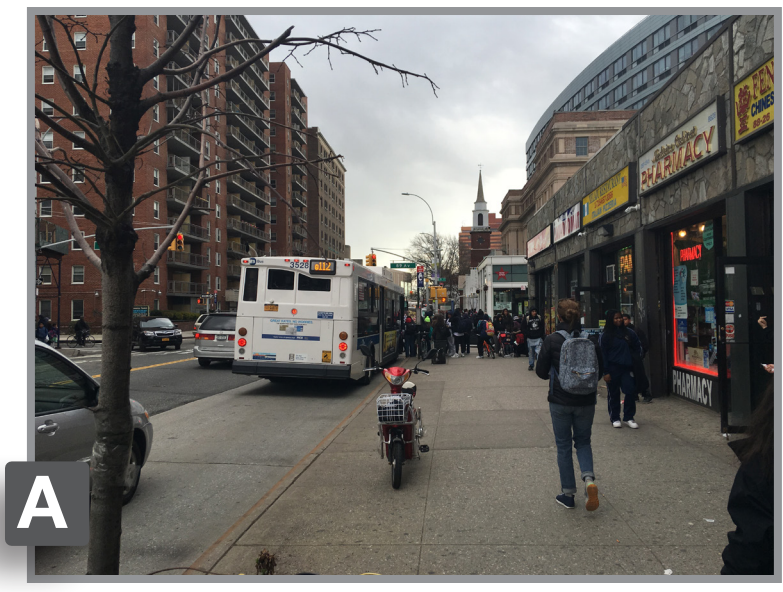
Bus stops and shelters are points of congestion in the sidewalk as people travel to residential, retail, civic, and religious destinations.

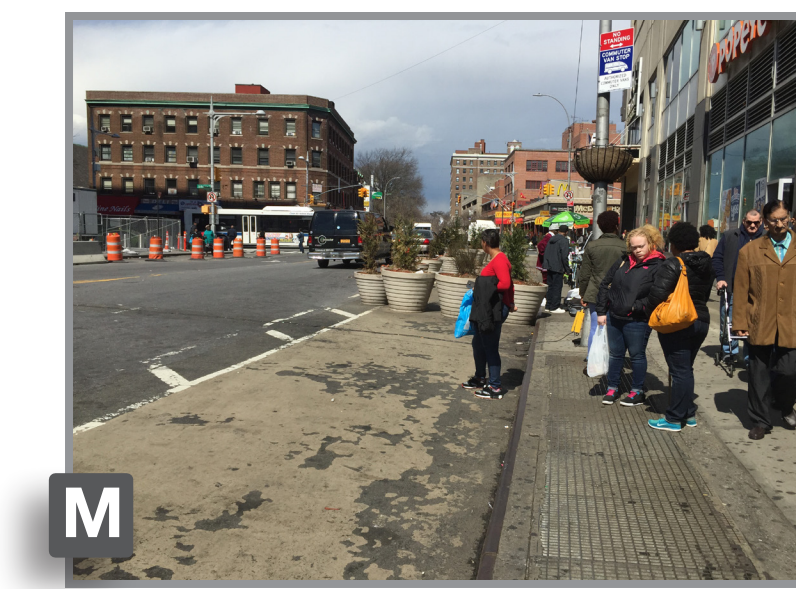
Passengers congregate at the sidewalk extension, divided by planters, where a formalized Commuter van waiting stop has been created.

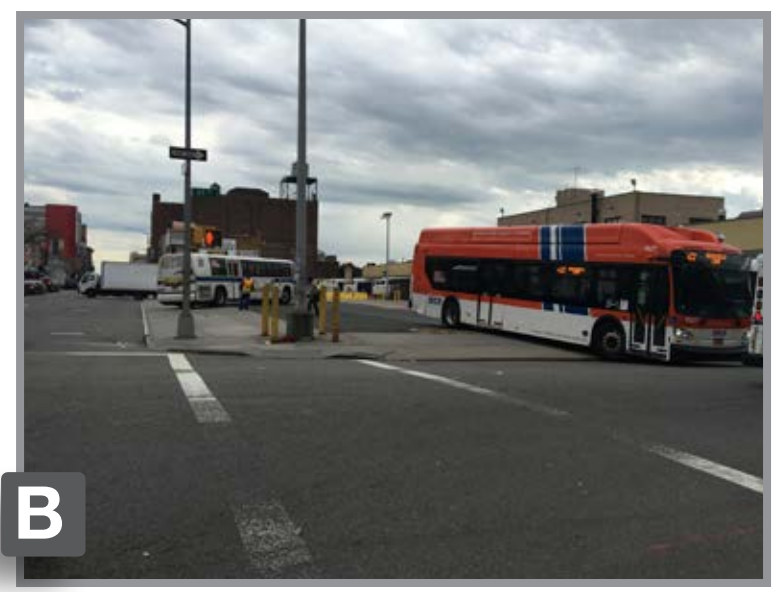
The 165th Street Bus Terminal experiences high volumes of buses pulling in and out of the parking lot, interrupting the sidewalk on the west side.

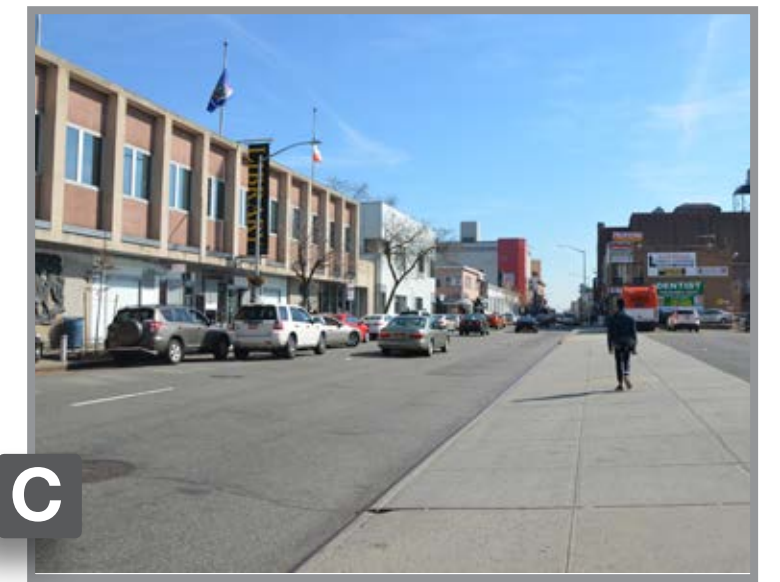
Large-scale mixed use buildings located near Jamaica Avenue draws the attention of the southern view corridor.

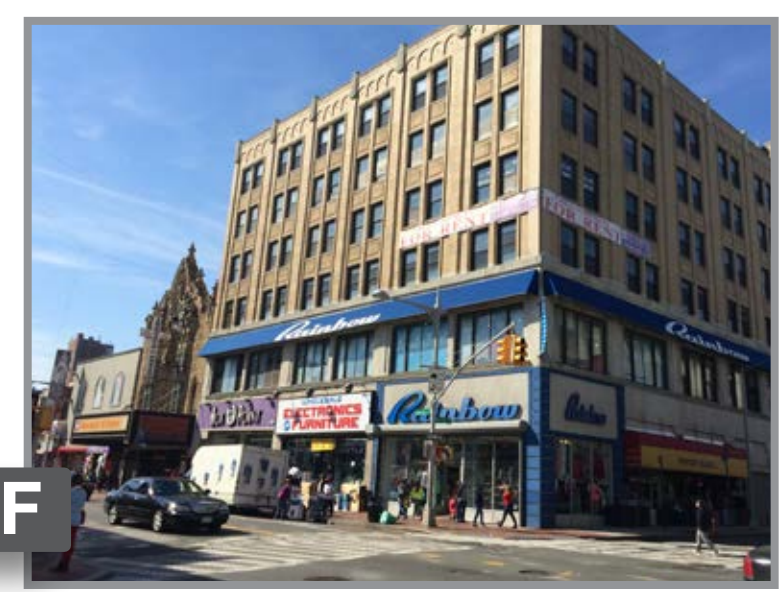
Ground floor retail on Merrick Boulevard is concentrated near Jamaica Avenue, including many established brands.

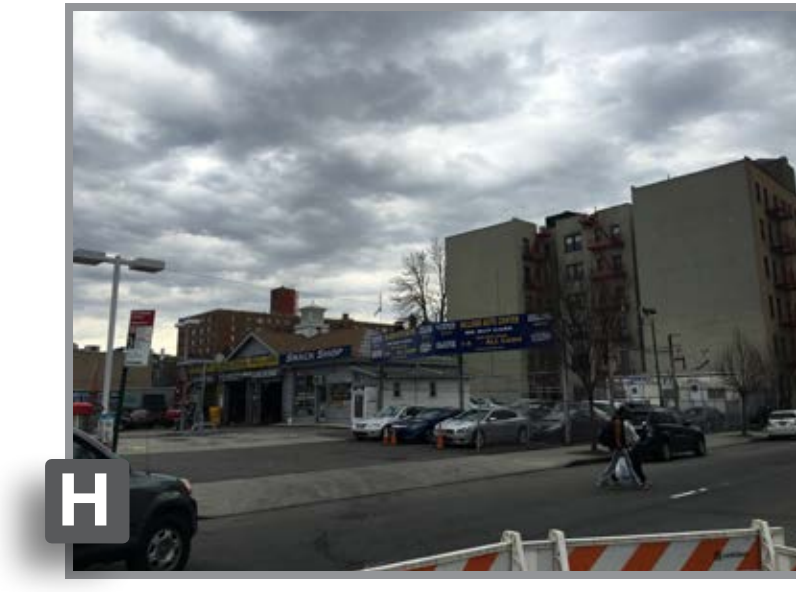
Sunoco gas station and auto repair center reflect the auto-oriented neighborhoods to the north of Hillside Avenue.

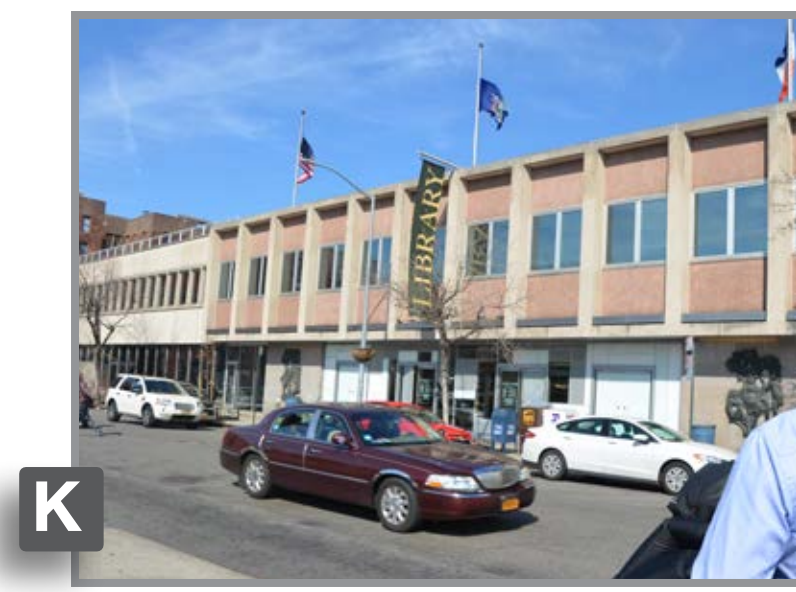
The Queens Library, a regional destination, is a synergy of the original Brutalist building and modern architectural styles.

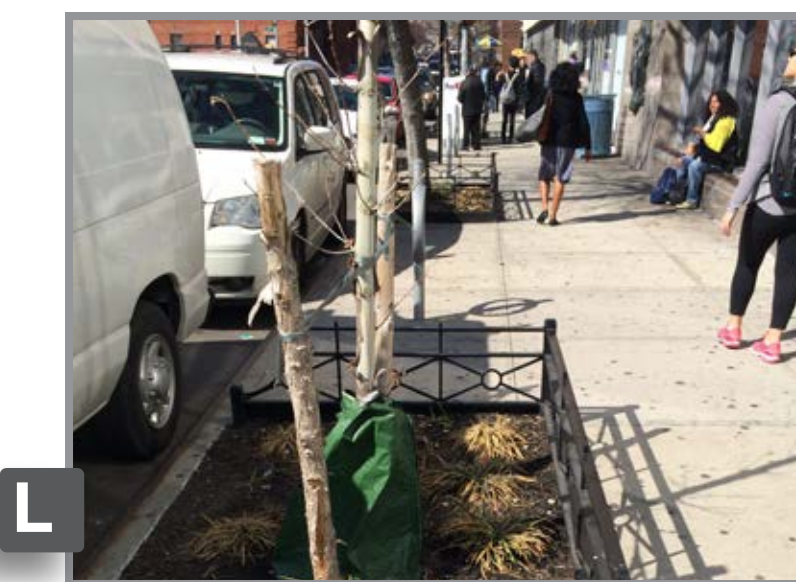
New tree pits and landscaping near the Queens Library.
